MOHAWK RIVER BASIN
BATAVIA KILL WATERSHED PROJECT
DAM No. 1

I.D. No. NY-615
PHASE I INSPECTION REPORT

Name of Dam: Batavia Kill Watershed Project Dam No. 1
I.D. No. NY-615 (#191c-3901)

Date of Inspection: July 11, 1978

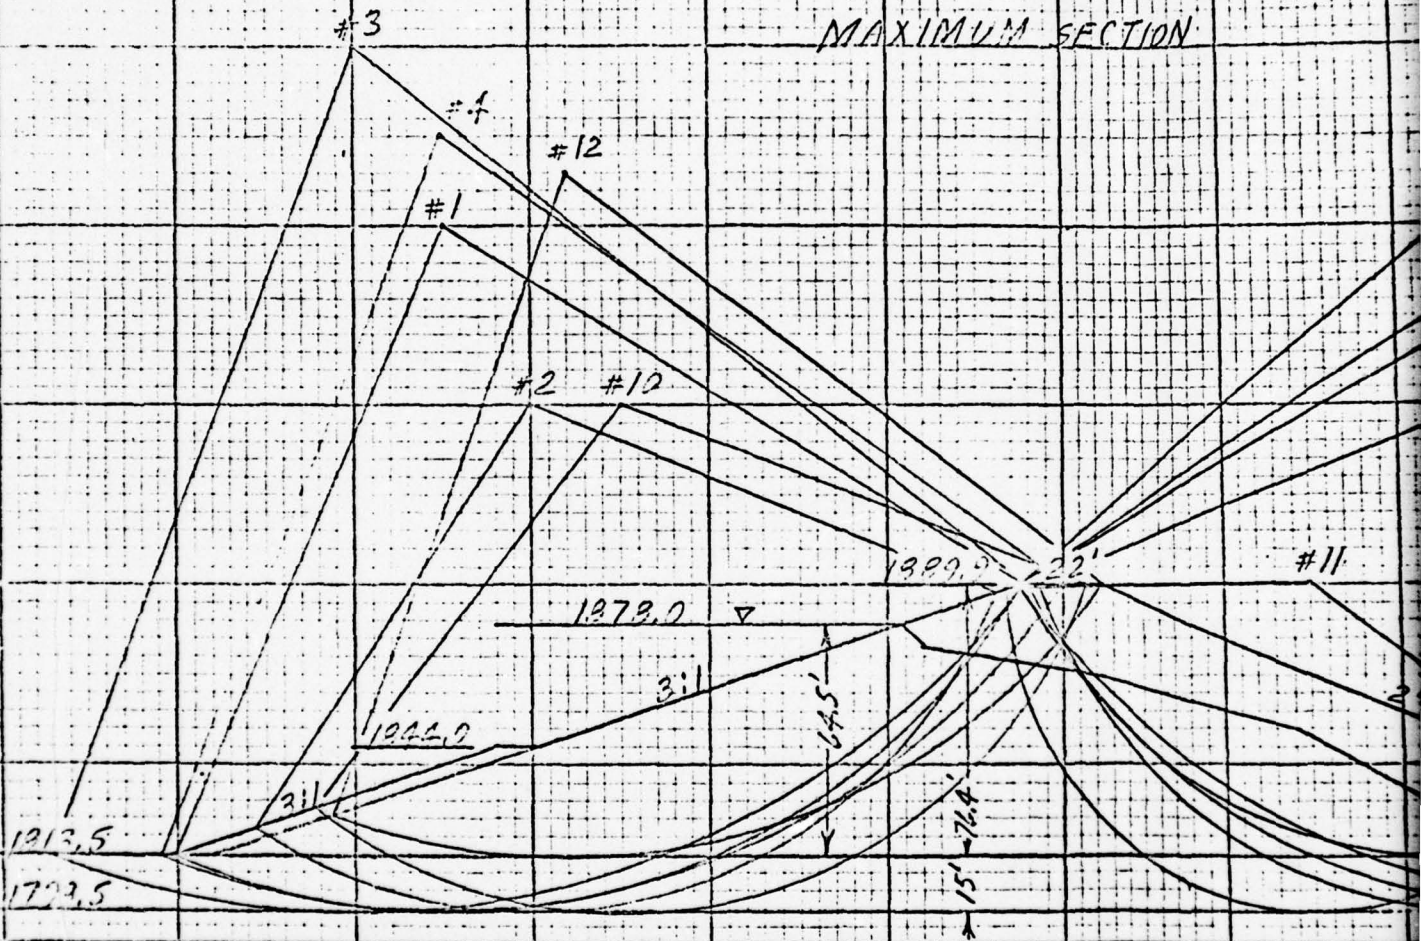
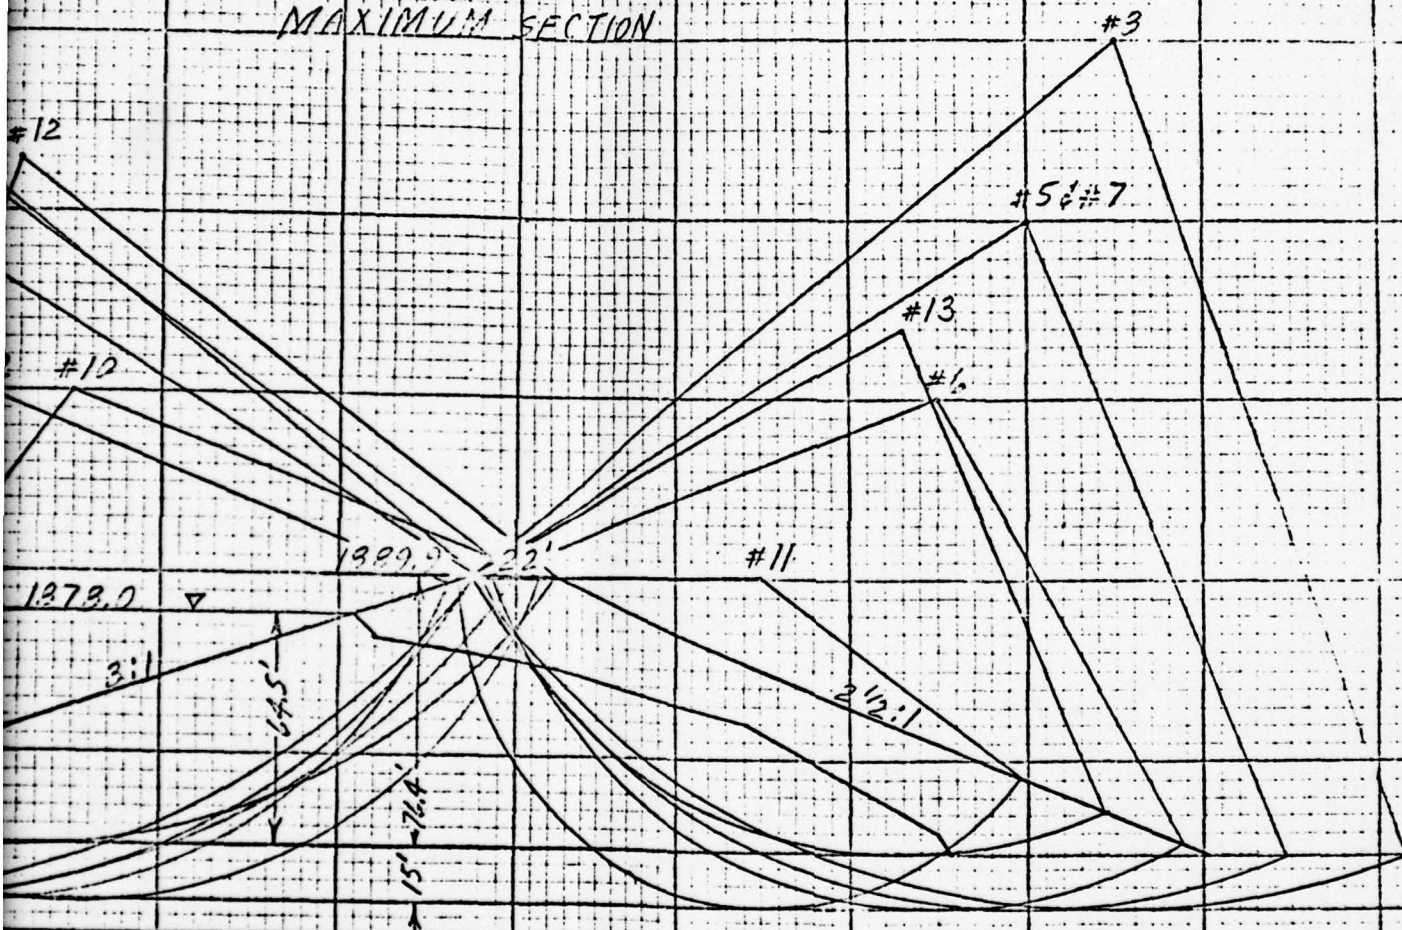
MAXIMUM SECTION

The downstream 2 1/2:1 slope yielded a safety factor of 1.31 (Trial #9) for the "immediately-after-construction" condition for the 76-foot high maximum section. The 3:1 upstream slope will have a safety factor greater than 1.31 for the same condition.

The long-term stability analysis of the 3:1 upstream slope under full drawdown conditions gave a safety factor of 1.61 (Trial #1) with a 10-foot berm at elevation 1844. The downstream 2 1/2:1 slope with a drain at $c/b = 0.6$ yielded a safety factor of 1.75 (Trial #5).

A stability analysis was also made of the interim condition between the post-construction (no consolidation) condition and the long term consolidated condition. Full drawdown conditions were assumed on the upstream slope and no consolidation in the foundation ($c = 1240$ psf). A minimum safety factor of 1.28 (Trial #10) was obtained for this analysis of the 3:1 upstream slope. The analysis of the interim condition for the 2 1/2:1 downstream slope with a drain at $c/b = 0.6$ gave a minimum safety factor of 1.32 (Trial #11).

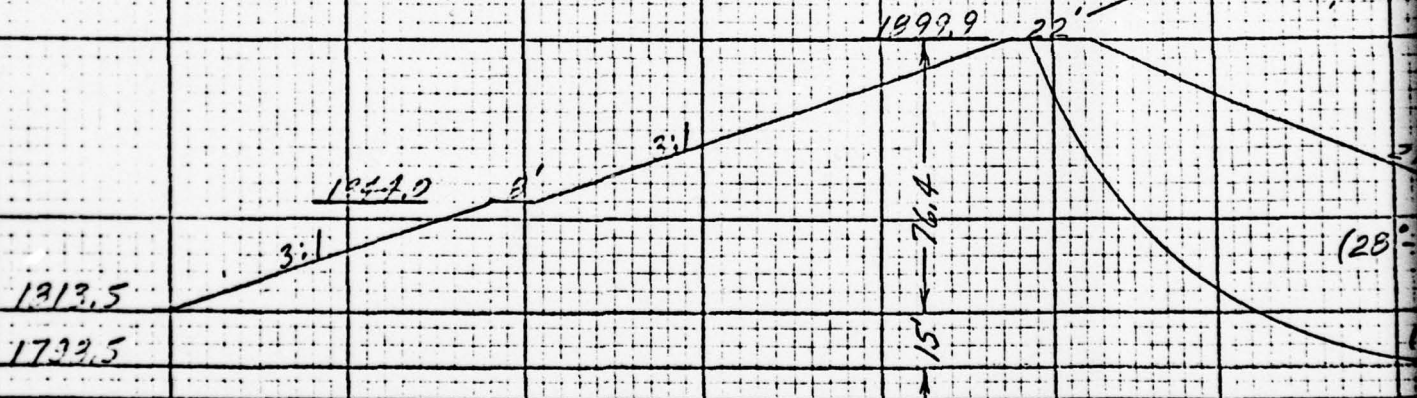
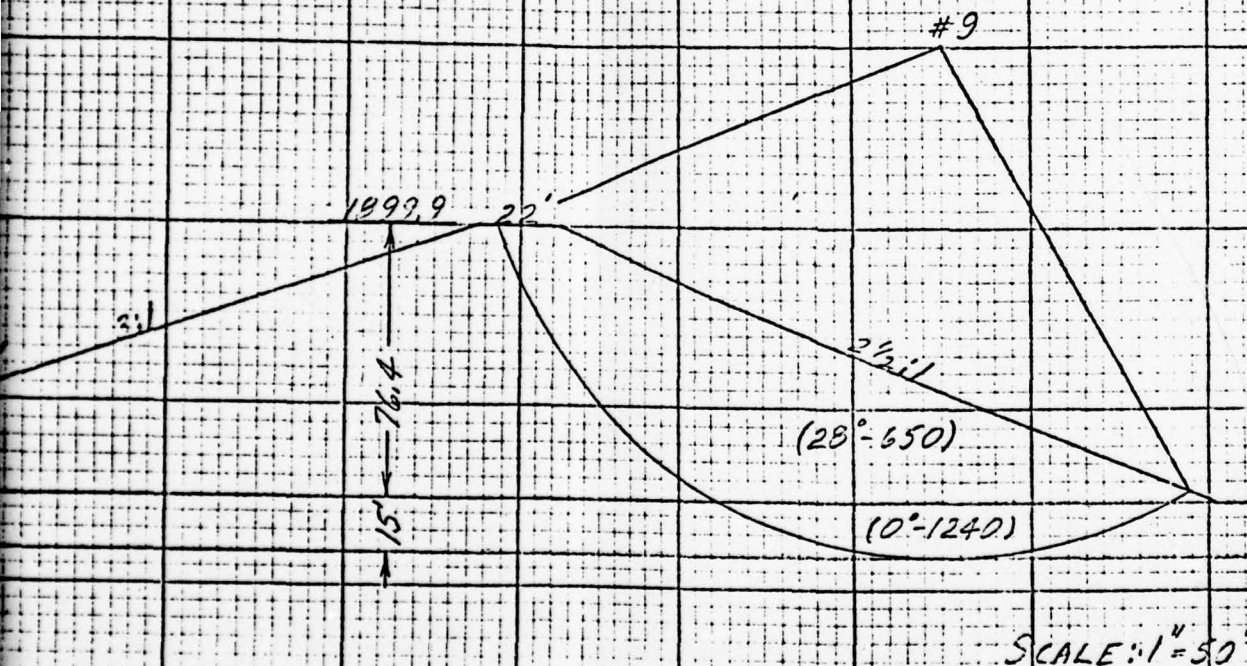
MAXIMUM SECTION
IMMEDIATELY AFTER CONSTRUCTION

The downstream 2 1/2:1 slope yielded a safety factor of 1.31 (Trial #9) for the "immediately-after-construction" condition for the 76-foot high maximum section. The 3:1 upstream slope will have a safety factor greater than 1.31 for the same condition.
